SUBJECT: Sheen in West Basin after Rainfall on November 10, 2020

SUBJECT: Sheen in West Basin after Rainfall on September 3, 2020

SUBJECT: Sheen in West Basin During Tropical Storm (TS) Laura

SUBJECT: Stormwater Outfall 006 and 007 Exceedance March 21, 2020
TPDES Permit No. VI0000019

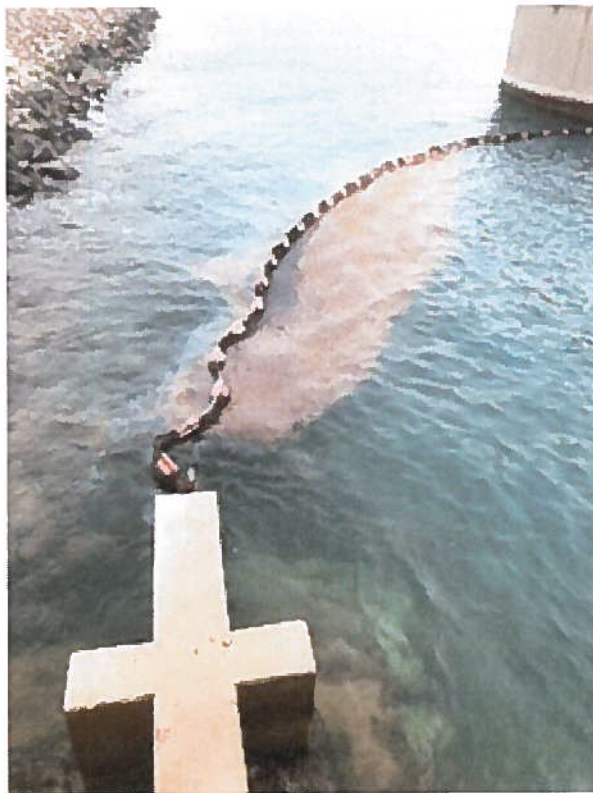
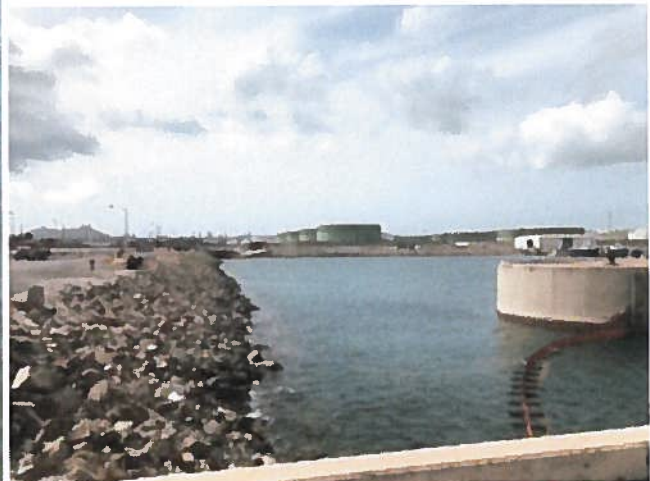
Good Morning Ben, Limetree had a spill today Dock 8 which is out of service. The spill occurred when they were removing a spool piece for Maintenance.

This dock is located in the northwestern most corner of the harbor posing no risk of leaving the harbor. The quantity is less than 5 gallons. Booms have been deployed and boats are in the harbor to make sure all sheen is sweeps up. I will send a follow up email when cleanup is complete.

Clean up complete. Coast Gaurd was onsite and happy with the clean up. All sorbent boom has been removed and being processed for disposal. A New Hard boom has been put in place.
